Hedrick Acres Neighborhood Pocket Park

Prepared by:
Eric Meadows - Cooperative Extension Fellow

Prepared for:
Hedrick Acres Neighborhood Association

April, 2007

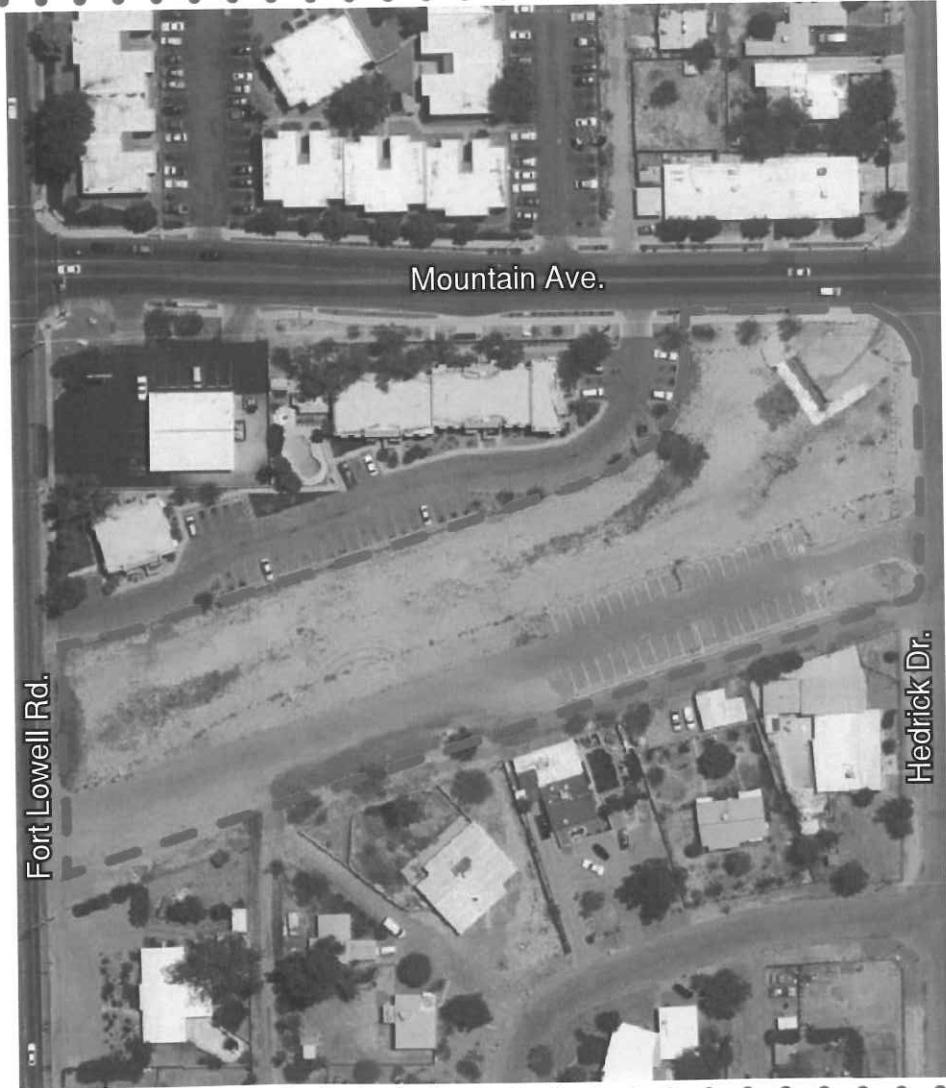
Location - The Navajo Wash is an approximately two acre parcel of land owned by the city of Tucson. It was formerly used by the Department of Transportation as a storage area. Presently it functions primarily as a storm water management site. At the southeast corner of the site there exists a large drainage basin which two surface washes flow into. The other aspect of the site involving storm water management is a drainage channel (unpaved) which runs the length of the site. This channel helps convey any excess water, not drained by the basin, into larger drainage systems. At present the only other use contained within the site is a 40 space parking lot. This lot is used by university commuter students who catch the CATRAN bus system at a nearby stop.

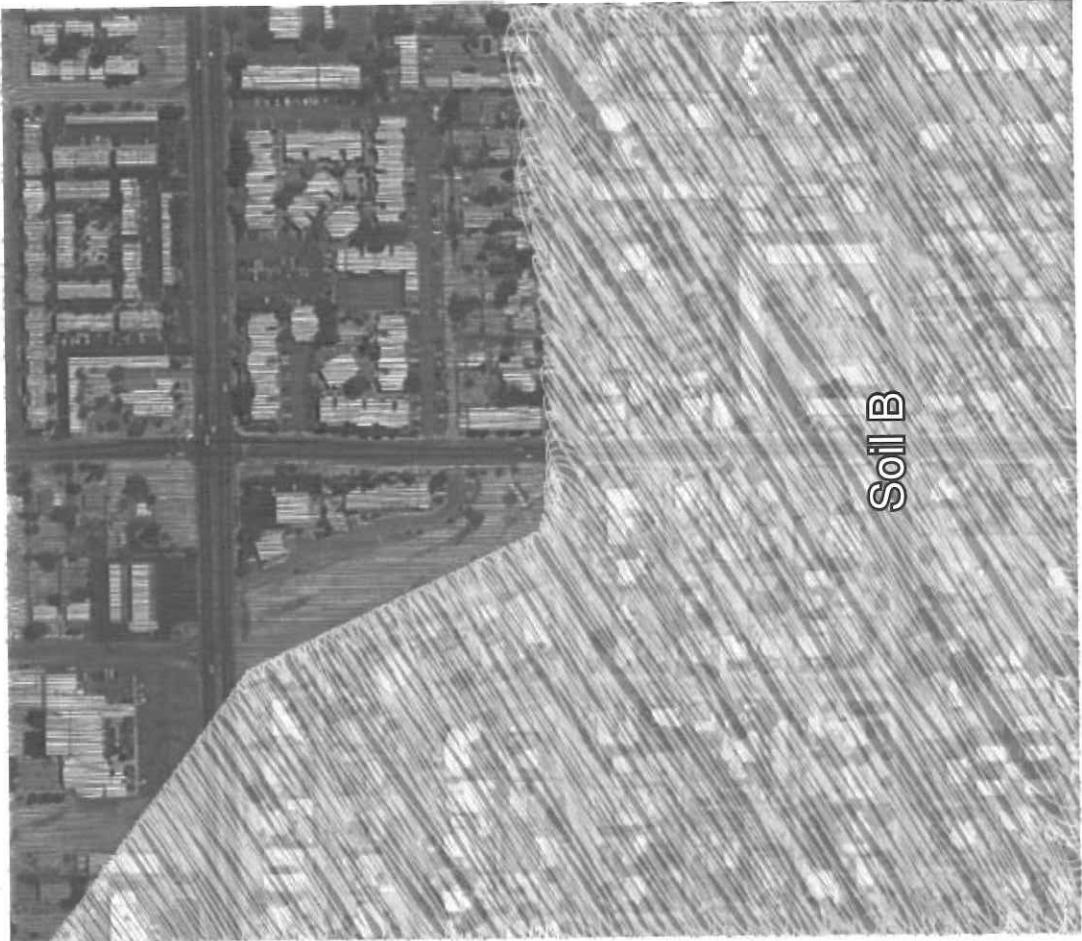
Soil B

- **Soil Conditions** - The soil conditions within the Navajo Wash site are very similar to those that exist across the Tucson Valley. There exists little to no organic materials that generally make up O and P soil horizons. What is seen at the surface are typically A horizon soils. In a representative profile these soils are pale-brown gravelly loam at a depth of 11 inches. Below this is a layer of white indurated hardpan that is approximately 31 inches thick. The soil is moderately alkaline and calcareous throughout. Permeability is moderate to moderately rapid through the gravelly loam but once it reaches the hardpan it is slow. Planting root depth ranges from 4-20 inches.

- Within the drainage channel on site we can assume that the soils here are even more compacted and in many cases may closely resemble concrete. Adding vegetation will help break up the soils within the site at large and help increase permeability.

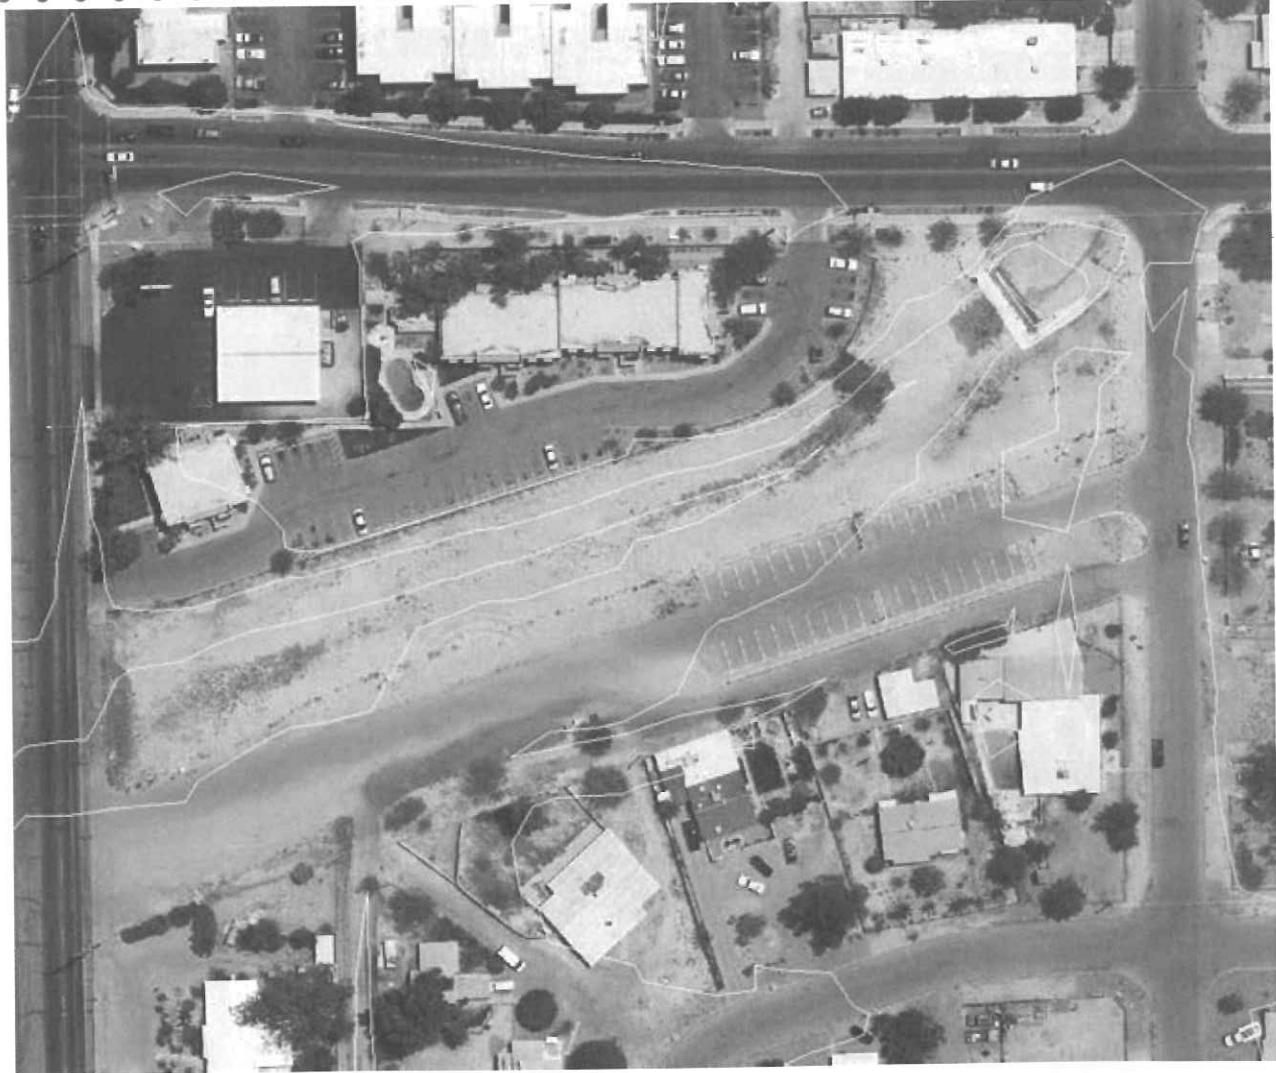
- **Topography** - The topography of the site follows the natural topography which drops as one moves from the southeast to the northwest of the site. The slope in this direction is a gradual one to two percent. Within the site itself the parking lot sits approximately 4 feet above the wash channel surface elevation. There are no drainage problems of concern within the site primarily because if there were, the site would not be doing its job. Any modifications to the site should be done at grade or below grade to ensure that water flows are not hindered, diverted, or damaged.

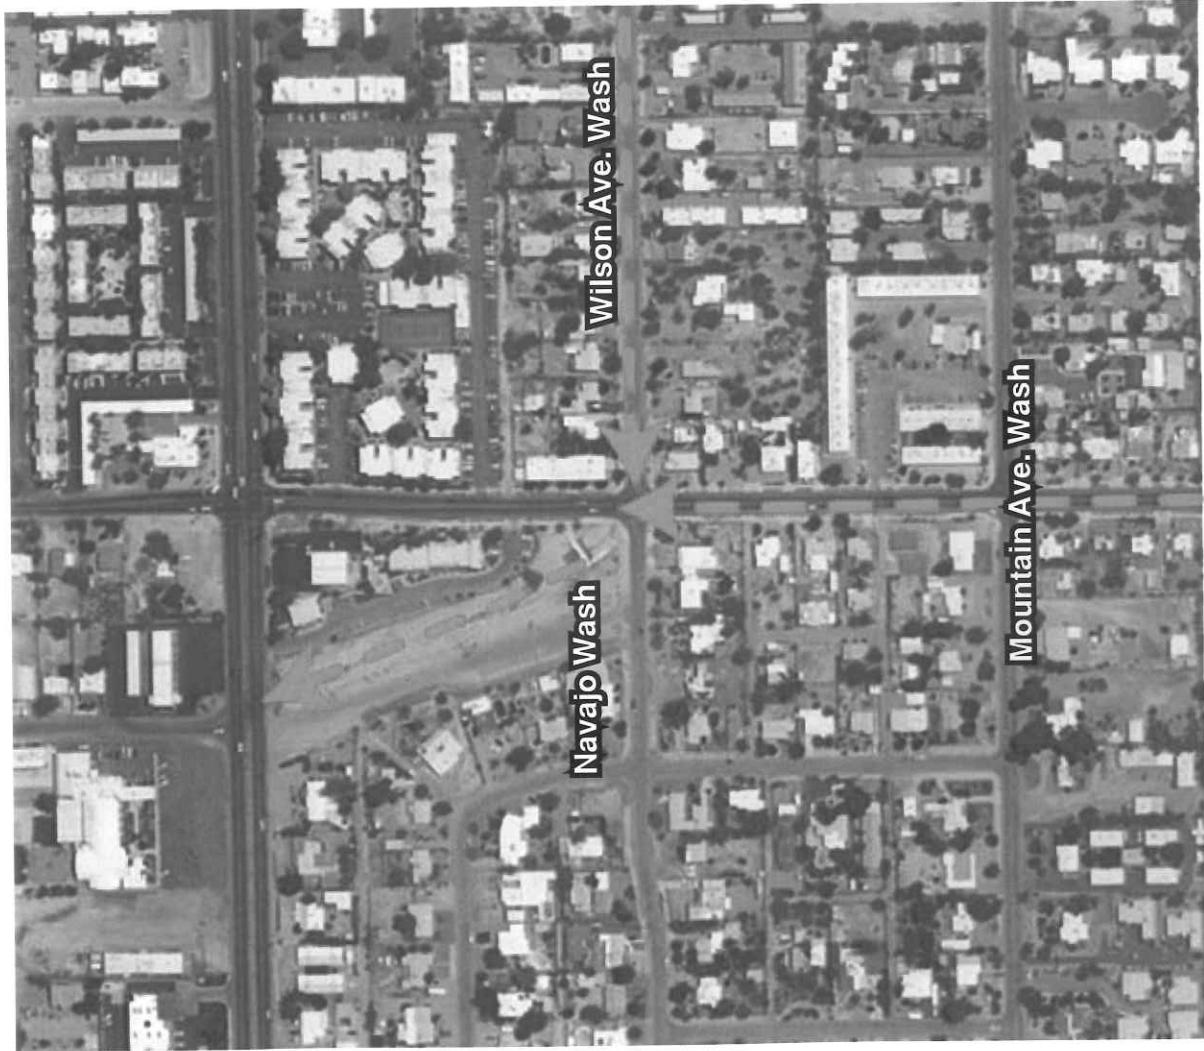
Local Washes - The Navajo Wash
Wash is a secondary wash within the Tucson city limits.
The Navajo Wash begins at the corner of Mountain Ave. and Hedrick Dr. It is fed from the south by the Mountain Ave. Wash and from the east by the Wilson Ave. Wash.
The Mountain Ave. roadway in the year 2000 underwent city implemented improvements during which some major drainage modifications were done.

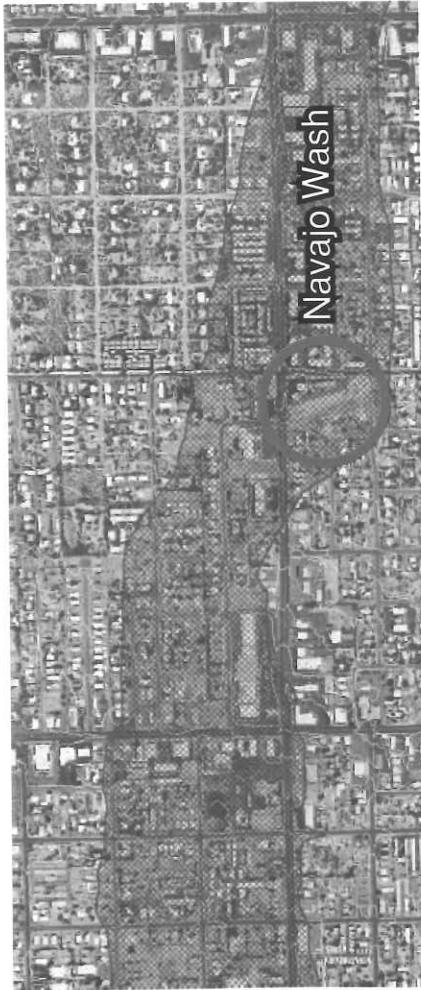
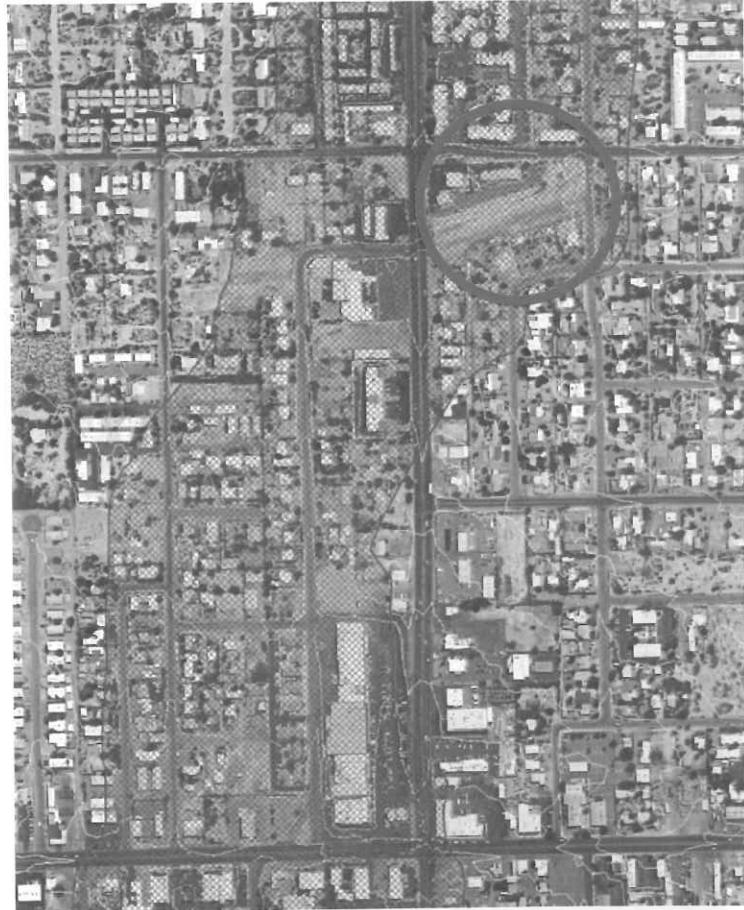
- **Watershed** - These two maps show at different scales the larger watershed of which the Navajo Wash is a part. When attempting to resolve local flooding and water related issues one must remember there are larger natural systems at work here. From the maps one can see that the Navajo Wash is part of a major east-west watershed within the Tucson city limits. Its defined area is approximately 1000 feet wide at any given point along its entire course. Once it reaches Oracle Rd. it contributes to the Flowing Wells Wash, which eventually drains into the Santa Cruz River.

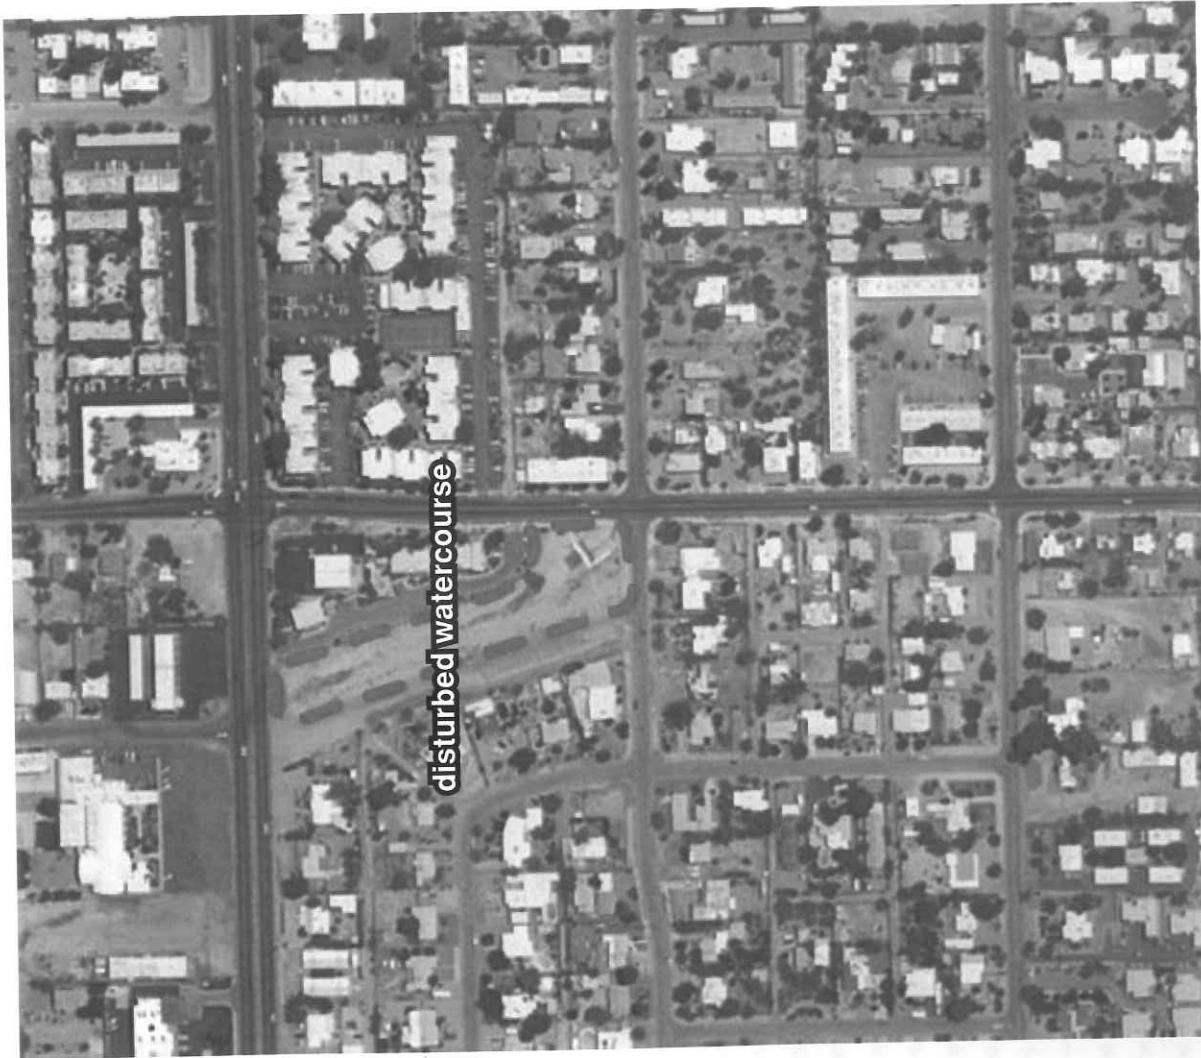
Disturbed Watercourse The city of Tucson has labeled the Navajo Wash site as a disturbed watercourse. In particular it is noted as having sparse vegetation. The area cannot host a high volume of vegetation because the possibility that this vegetation could hinder or divert water flow. But certainly the site can play host to thoughtful placement of vegetation clusters. These clusters are recommended to be placed on the higher elevation parts of the site and out of the wash channel. The banks of the channel can host single trunked trees placed in a direction parallel with the water flow.

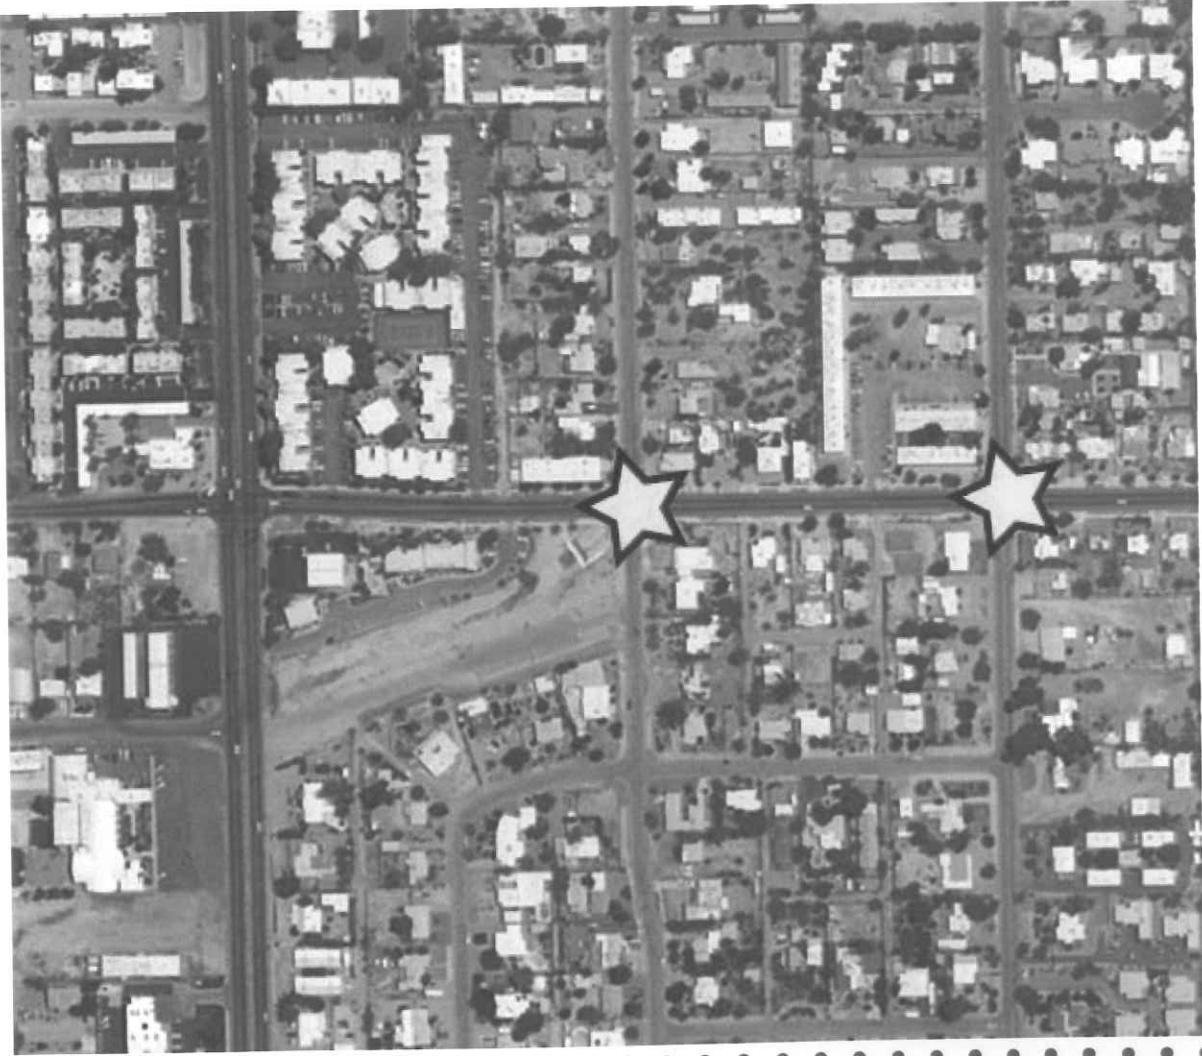
- Operation Splash - The intersections of Mountain Ave. and Hedrick Dr. and Mountain Ave. and Blackridge Dr. (shown with stars) are areas the city has recognized as areas subject to local flooding.
- While this localized flooding does not have major implications on the Navajo Wash site, these are two areas upstream which contribute to the overall quantity of water arriving on site. It can be assumed that any water not able to properly drain at these sites would continue downstream to the Navajo Wash.

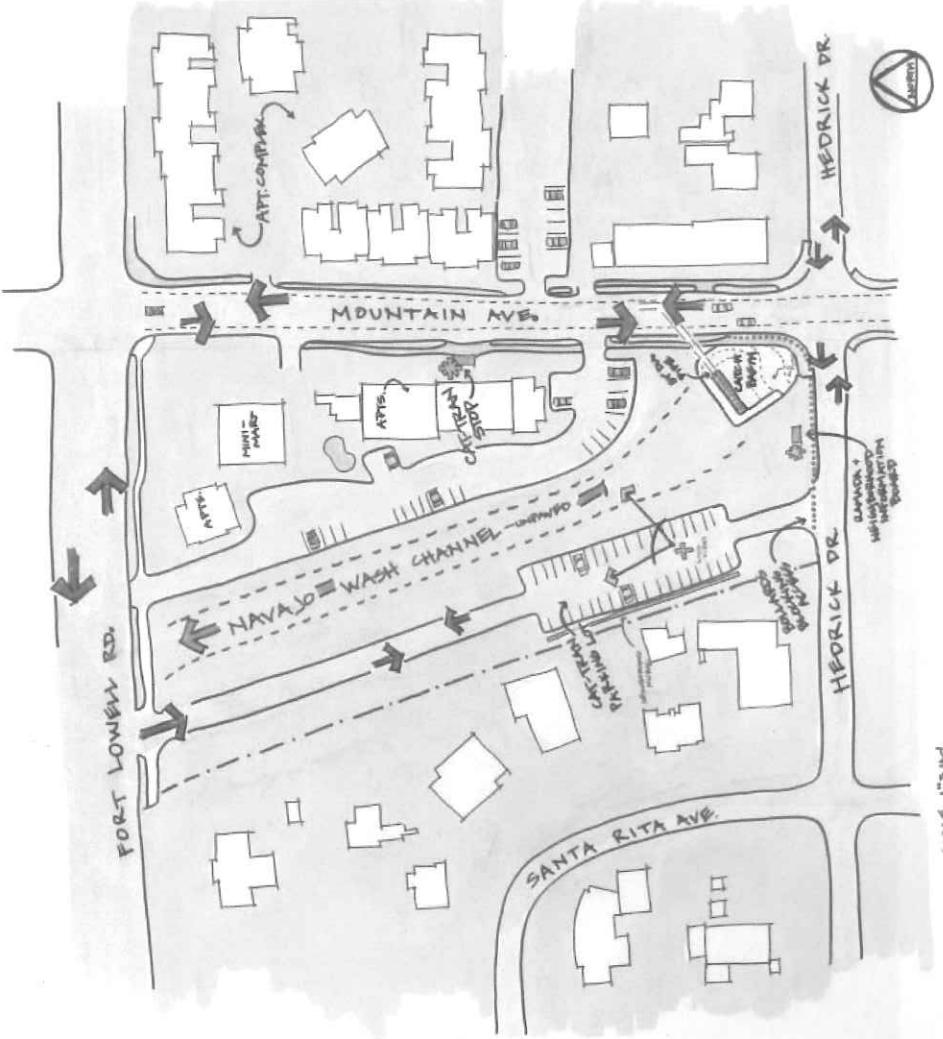
- Site Analysis - The Navajo Wash resides just off the intersection of Mountain Ave. and Fort Lowell Rd. These are two major transportation corridors within mid-town Tucson. To the west and south of the site are low density residential units. To the east are three-story apartment units.
- At the southeast corner of the site there is a major drainage basin. As indicated, currently existing on site is a small parking lot serving commuter students who use the CTRAN services to reach the university. Vehicular access to this parking lot is from Fort Lowell Rd. There are excellent views of the Santa Catalina Mountains to the north-northeast. Also located on site is a small ramada which houses the neighborhood activity/information board. The only vegetation existing on site is through chance natural occurrence primarily occurring around the drainage basin.

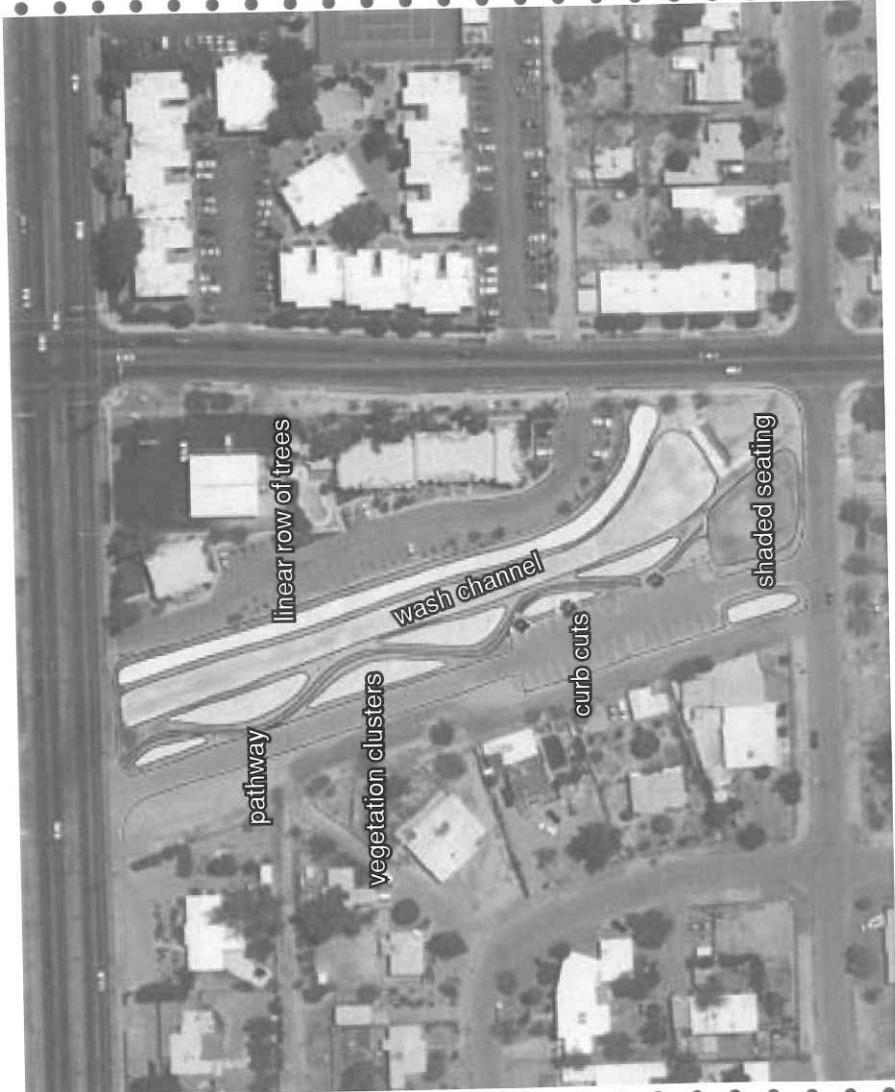
Concept - The Navajo Wash
parcel of land presents an excellent opportunity for a small, passive-use oriented pocket park for the Hedrick Acres Neighborhood. Some primary improvements include: addition of vegetation, establishment of wildlife habitat (bird and reptile), a designated pathway, curb cuts in the parking lot to promote water harvesting, and a shaded seating area. The establishment of wildlife habitat is accomplished through the use of native vegetation occurring in small clusters, with those clusters containing structurally diverse vegetation. The main wash channel has been left clear so as to not disrupt any water drainage during major rain events. No paved surfaces have been added. The added vegetation should aid in making the soils more permeable.

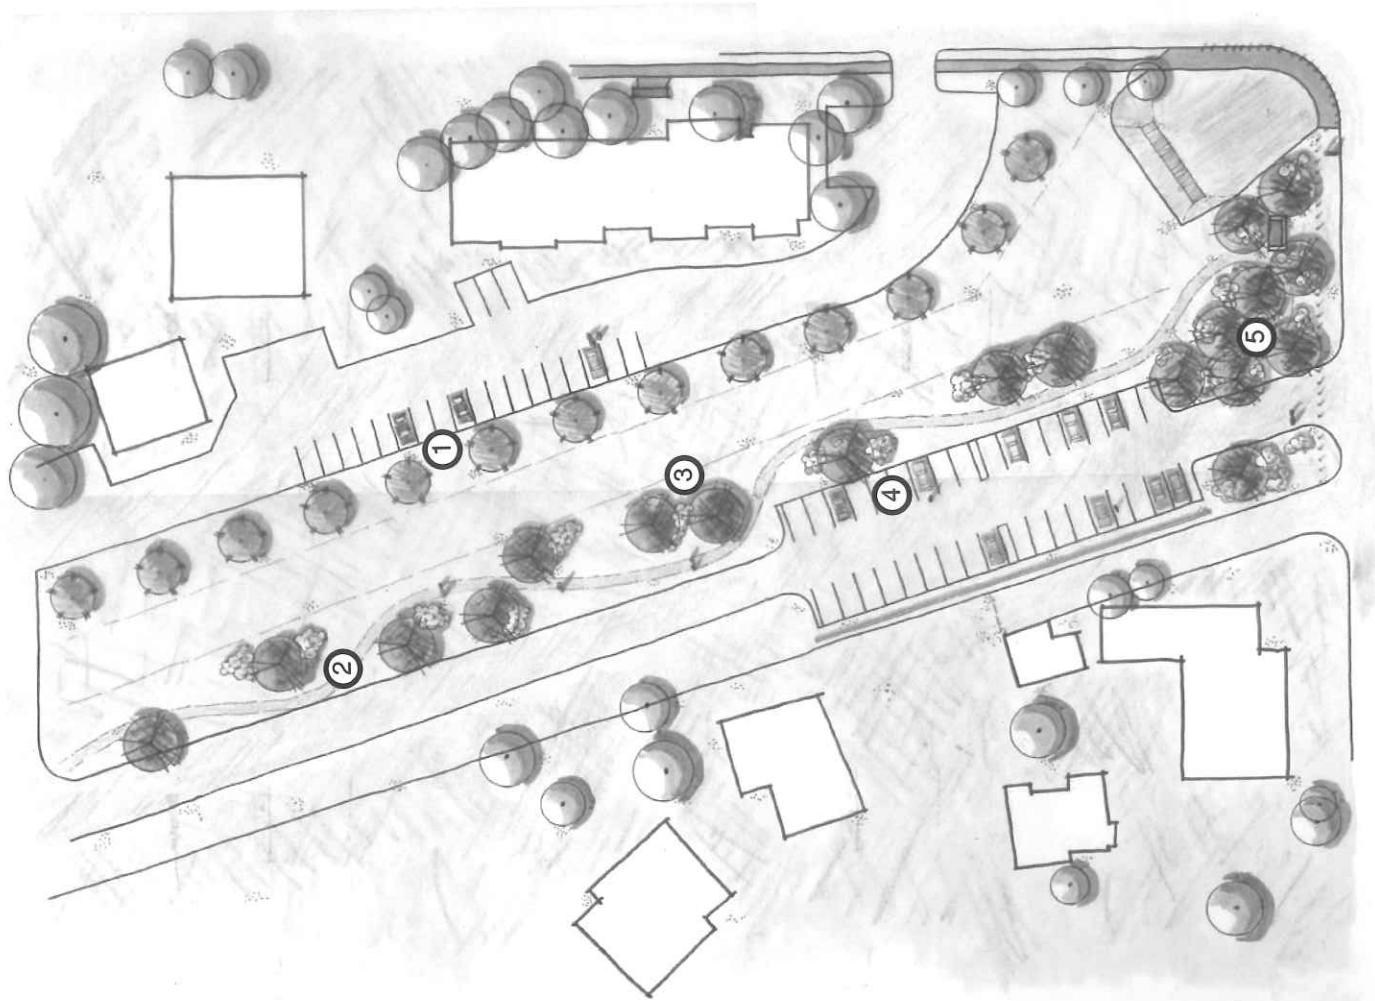
Navajo Wash Masterplan

- 1. **linear row of trees** - located on the steeper east slope leading out of the wash channel a long row of trees is proposed running parallel to the direction of water flow.
- 2. **pathway** - a designated non-paved pathway runs the entire length of the wash parcel.

- 3. **small vegetation clusters** - are placed intermittently along the length of the pathway.
- 4. **curb cuts** - a series of curb cuts within the existing parking lot is proposed to promote rainwater harvesting. These curb cuts drain into swales which help supply water to adjacent clusters of vegetation.

- 5. **mesquite bosque** - a small cluster of native mesquite trees surrounds the existing community bulletin board. This dense cluster of trees provides plenty of shade for the benches placed underneath their canopies. The pathway at this point makes a loop, completing back onto itself.

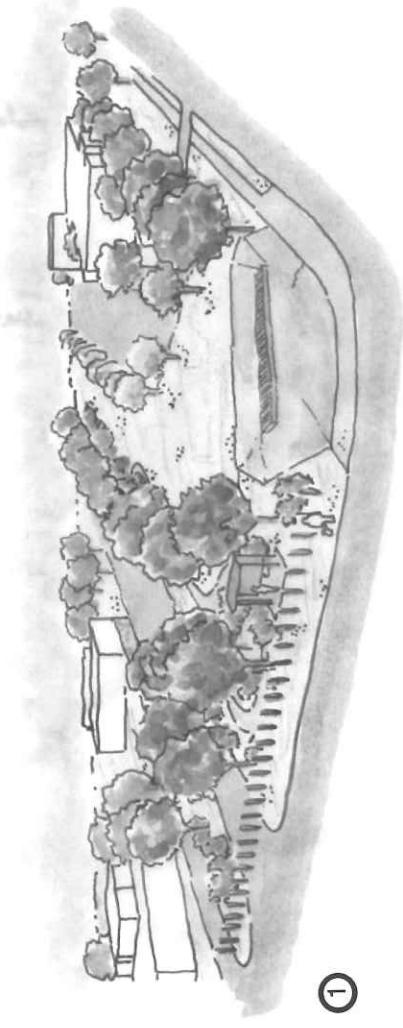
①

- 1. This perspective shows a view of the Navajo Wash from the south. In the foreground one can see the current community activity board now surrounded by a small bosque of mesquite trees. Within this area the path makes a large loop and it is recommended benches be placed here to take advantage of shaded seating opportunities.

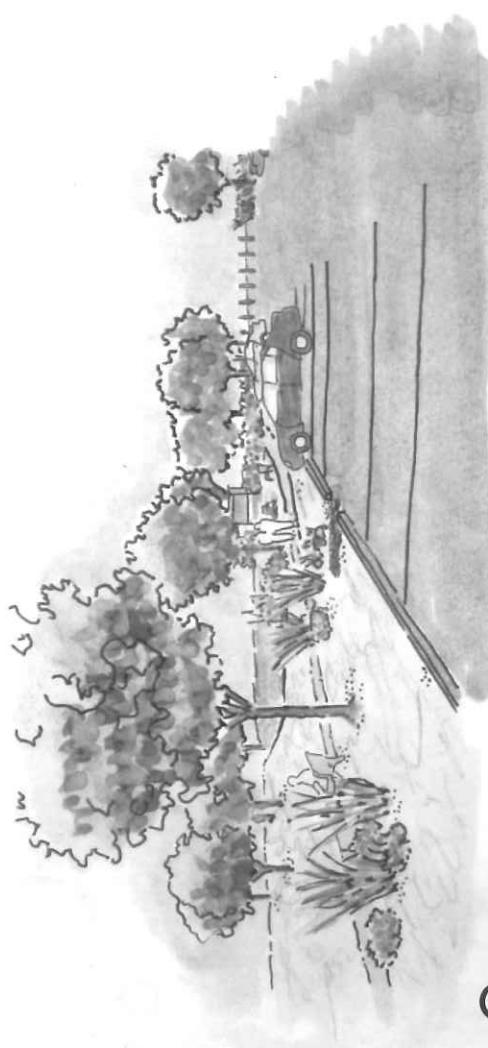
②

- 2. This perspective is from the northern reaches of the parking lot facing south. Shown on the left is the proposed pathway. Along the length of this pathway there would be small clusters of native vegetation that receive rainwater harvested off the parking surface. Benches interspersed would provide for resting and viewing.

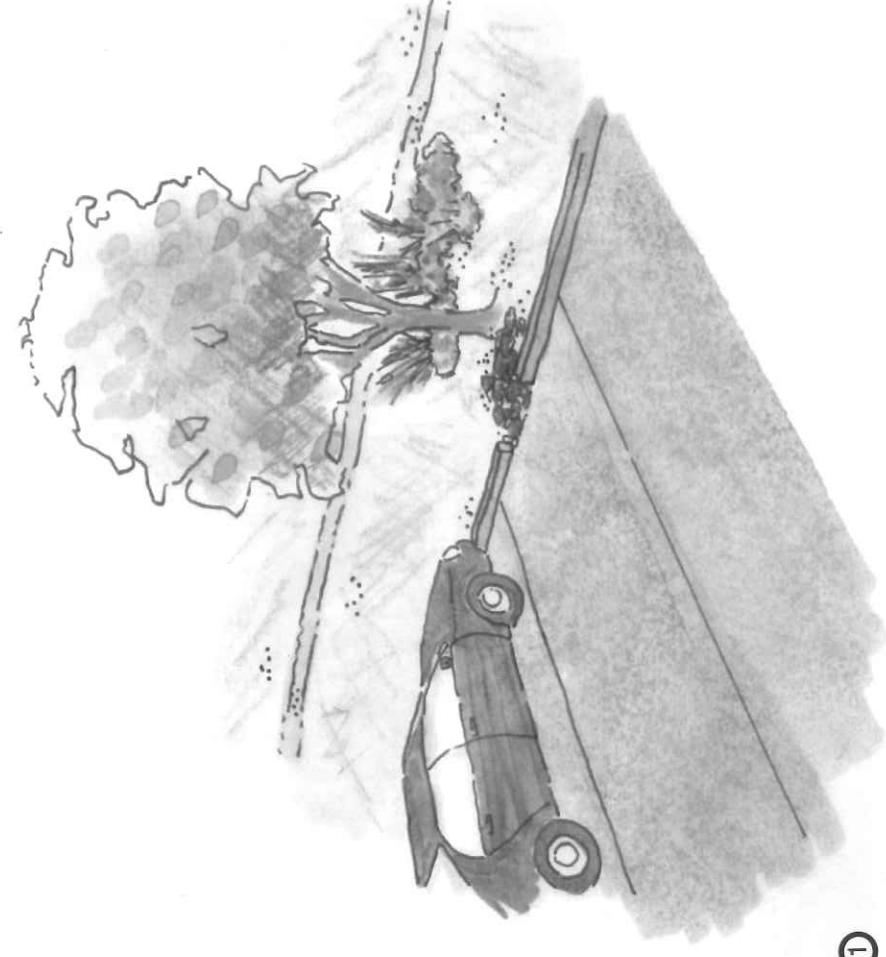
①

1. A series of curb cuts is proposed within the existing parking lot. These curb cuts will help promote rainwater harvesting by directing surface runoff from within the paved parking surface into small vegetated basins. The use of native vegetation, adapted to the natural climate and precipitation rates will help ensure that the site stays vegetated.

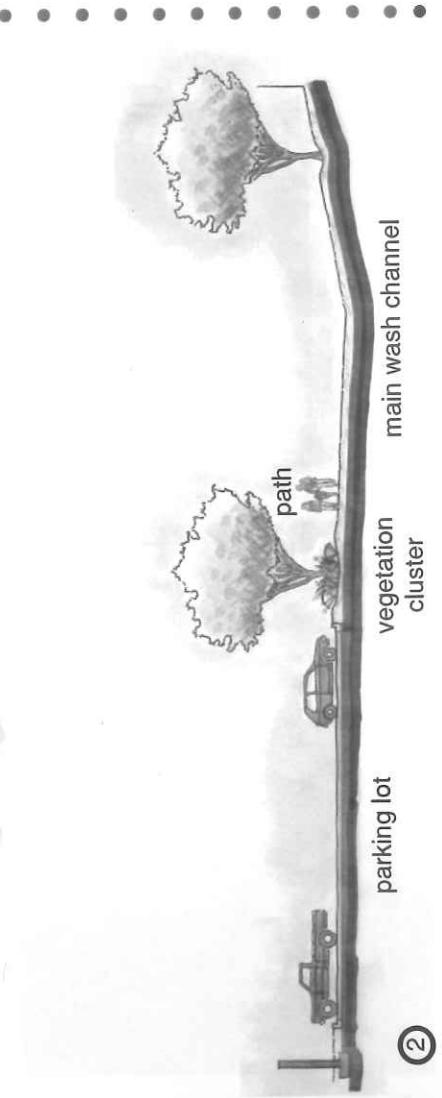
2. This section drawing depicts an east-west cross section of the wash site with incorporated improvements.

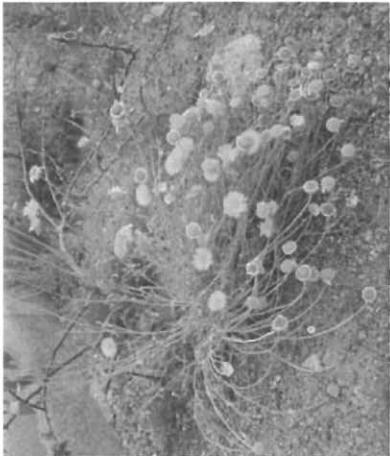
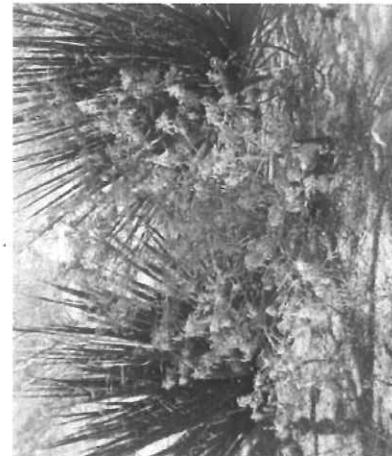
Native Annuals/Forbs

Bahia absinthifolia - Bahia (top left)

Kallstroemia grandiflora - Summer poppy (bottom left)

Lesquerella gordoni - Bladderpod (bottom right)

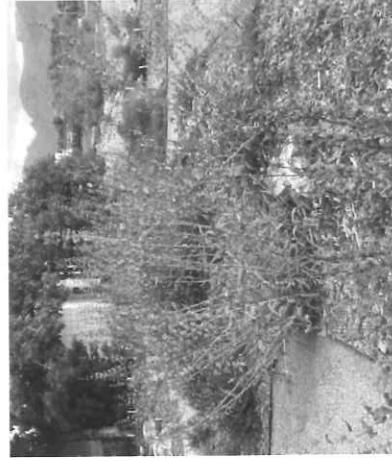
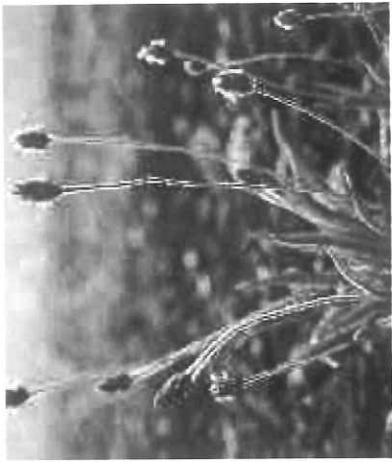
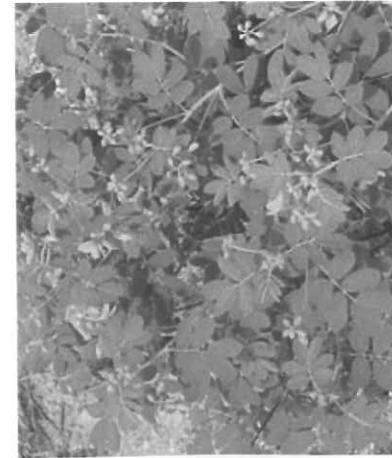
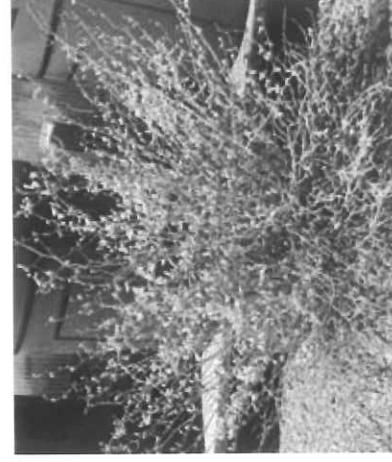
Native Annuals/Forbs

• *Penstemon parryi* - Parry penstemmon (top left)

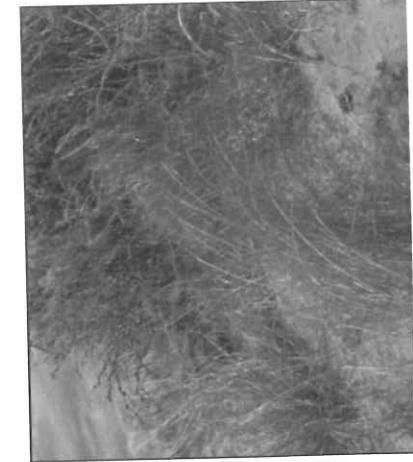
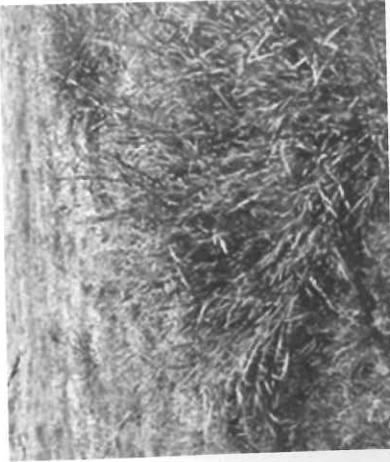
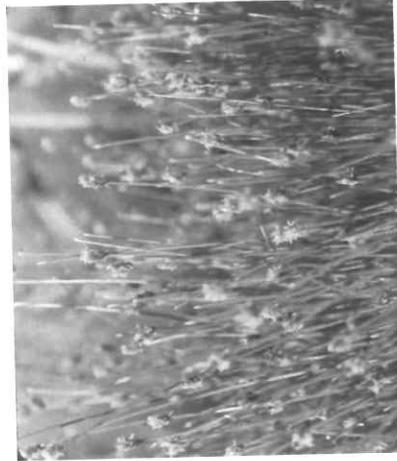
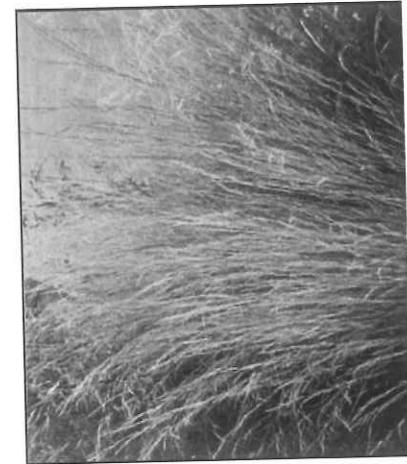
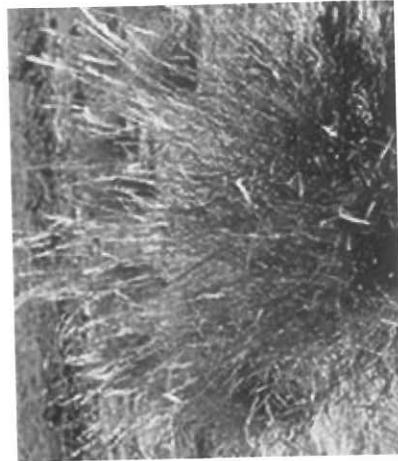
- **Native Grasses**
- *Sporobolus cryptandrus* - Sand dropseed (top left)
- *Sporobolus contractus* - Spike dropseed (top right)
- *Enneapogon desvauxii* - Pappusgrass (middle left)
- *Aristida purpurea* - Purple threeawn (middle right)
- *Bouteloua rothrockii* - Rothrock grama (bottom left)
- *Digitaria californica* - Arizona cottontop (bottom right)
